GISTM Disclosure Report: El Torito Tailings Storage Facility

This Report summarises information related to El Torito Tailings Storage Facility (TSF), including data specified by the Global Industry Standard on Tailings Management (GISTM)¹ Requirement 15.1 as well as a summary of current GISTM conformance levels.

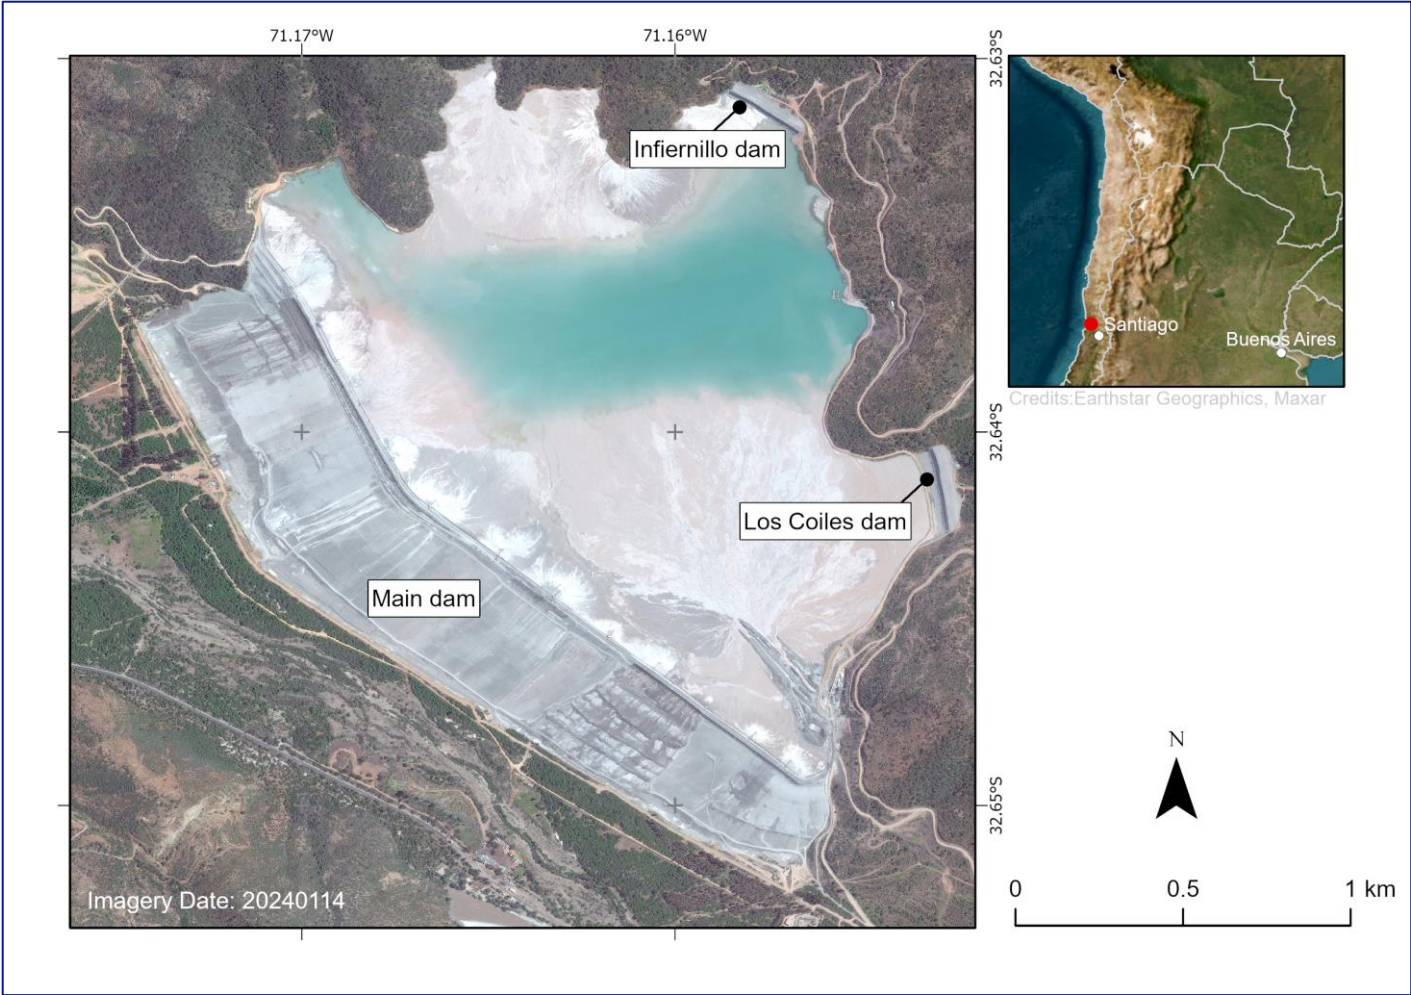
Figure 1. El Torito TSF general arrangement and location

El Torito TSF is an active facility consisting of three dams: Main dam, Infiernillo dam, and Los Coiles dam, located northwest of the plant within Anglo American’s Chile-based El Soldado Operation. Figure 1 and Table 1 present the general arrangement and location of El Torito TSF, and the key characteristics, respectively.

| Description | | Comment |
|---|--|---|
| Construction Method & Summary | Main dam: Centreline dam ³ Los Coiles & Infiernillo dams: Downstream dams ⁴ | <p>El Torito TSF comprises a Main dam and 'back' saddle dams, which are referred to as the Los Coiles and Infiernillo dams.</p> <p>A 14 m tall starter dam with a 2.5H : 1V downstream slopes was constructed at the Main dam to support the commissioning and initial containment. The Main dam was then raised as a downstream compacted cyclone sand dam until 2005, when it was modified to be raised centreline, continuing with compacted cyclone sand.</p> <p>Two back dams, Los Coiles and Infiernillo, both downstream constructed rockfill dams, were built in 2020 to protect trees (Belloto del Norte) located northeast of these structures.</p> |
| Height (m): Current / Final | a) 102 / 108 b) 18 / 22.5 c) 18 / 22.7 | a) Main dam (Muro Principal) b) Infiernillo back dam c) Los Coiles back dam |

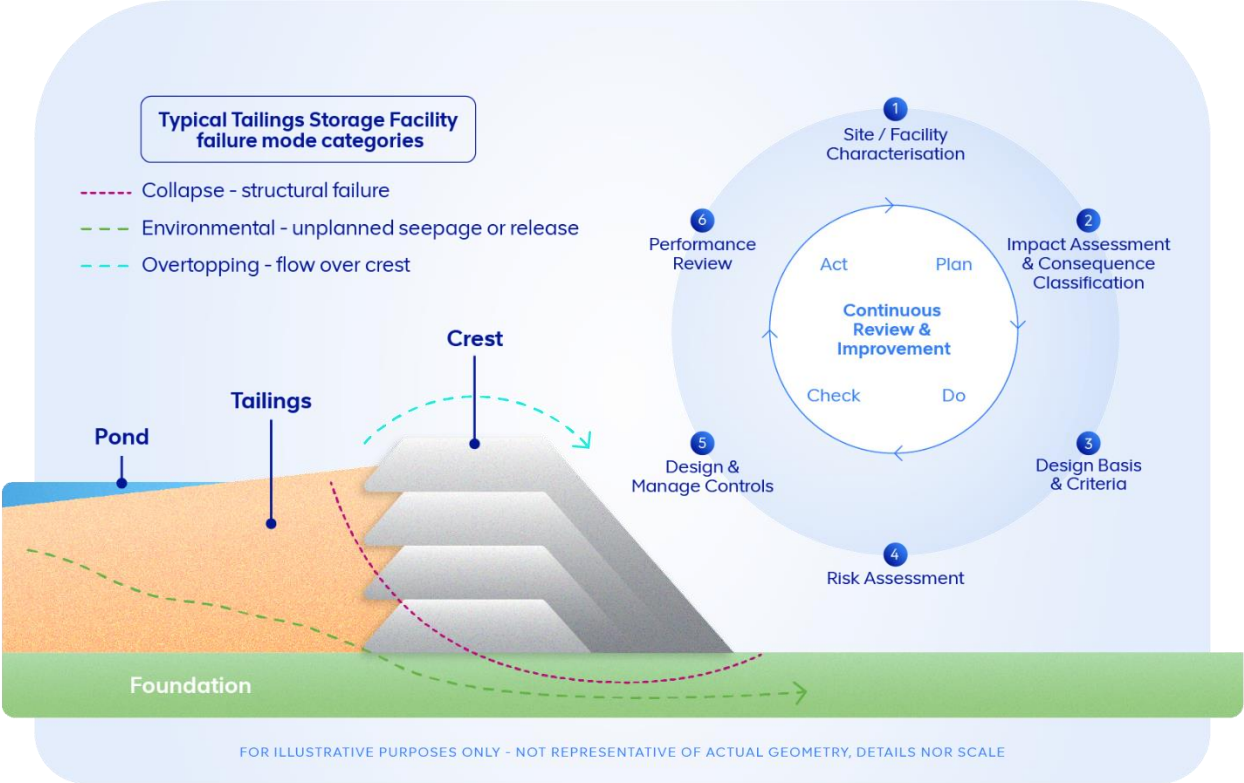
Figure 2. Failure mode categories and risk management framework summary

The Anglo American TSF risk management system comprises a series of interrelated and mutually reinforcing elements focussed on preventing and mitigating the potential impacts of ‘collapse’ and ‘overtopping’ failure modes, as well as other ‘environmental’ source-pathway-receptor type impact mechanisms (e.g., groundwater impacts). Figure 2 illustrates these key modes and mechanisms, within a conceptualised TSF cross-section and presents a simplified ‘process wheel’ overview of key TSF risk management system elements. Table 2 summarises the TSF risk management system elements. The Anglo American TSF risk management system has been updated to provide a framework to seek to ensure that all risks are well understood, communicated and managed, which includes means to assess appropriate risk reduction measures.
