GISTM Disclosure Report: Pérez Caldera Tailings Storage Facility

This Report summarises information related to the Pérez Caldera Tailings Storage Facility (TSF), including data specified by the Global Industry Standard on Tailings Management (GISTM)¹ Requirement 15.1 as well as a summary of current GISTM conformance levels.

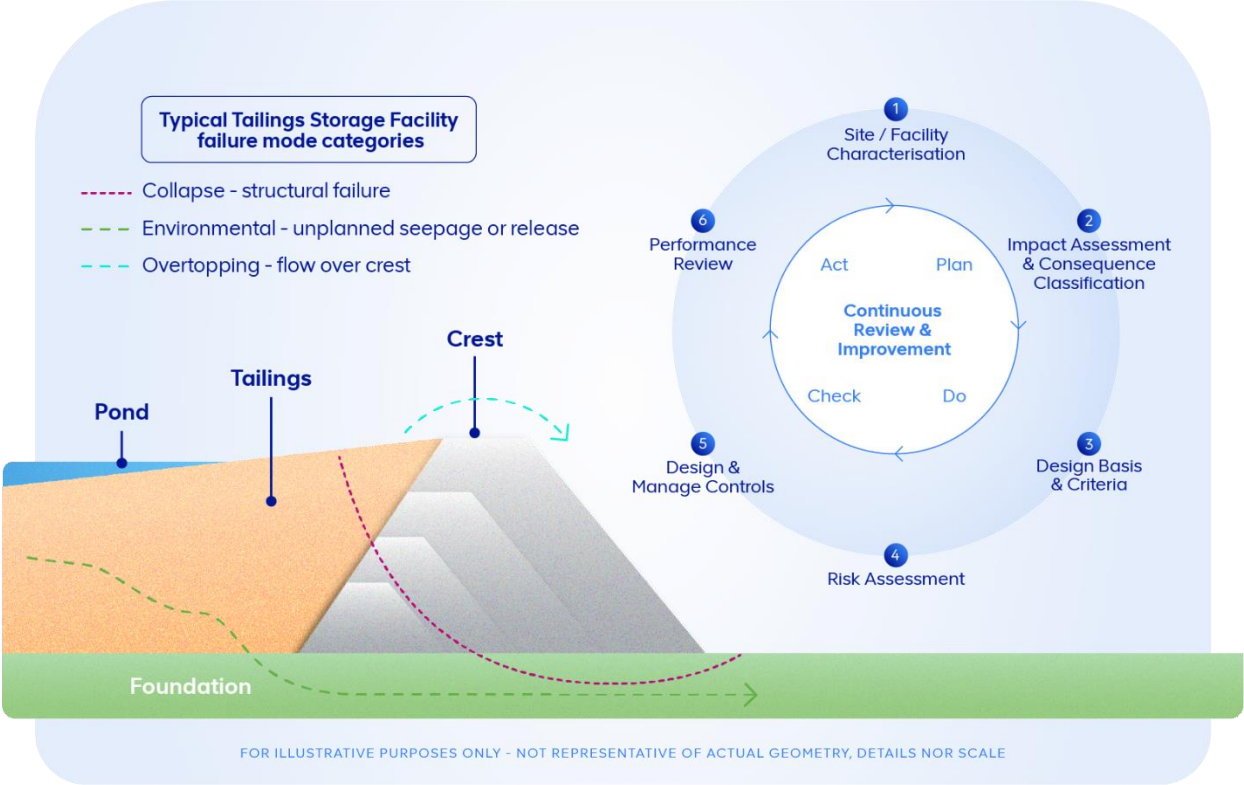
Figure 2. Failure mode categories and risk management framework summary

The Anglo American TSF risk management system comprises a series of interrelated and mutually reinforcing elements focussed on preventing and mitigating the potential impacts of ‘collapse’ and ‘overtopping’ failure modes, as well as other ‘environmental’ source-pathway-receptor type impact mechanisms (e.g., groundwater impacts). Figure 2 illustrates these key modes and mechanisms, within a conceptualised TSF cross-section and presents a simplified ‘process wheel’ overview of key TSF risk management system elements. Table 2 summarises the TSF risk management system elements. The Anglo American TSF risk management system has been updated to provide a framework to seek to ensure that all risks are well understood, communicated and managed, which includes means to assess appropriate risk reduction measures.
